Picture 1 – Foster Brothers Farm, 58 Lower Foote Rd., Middlebury, VT – 07/29/14  
Manure transfer area on the east side of the barns.

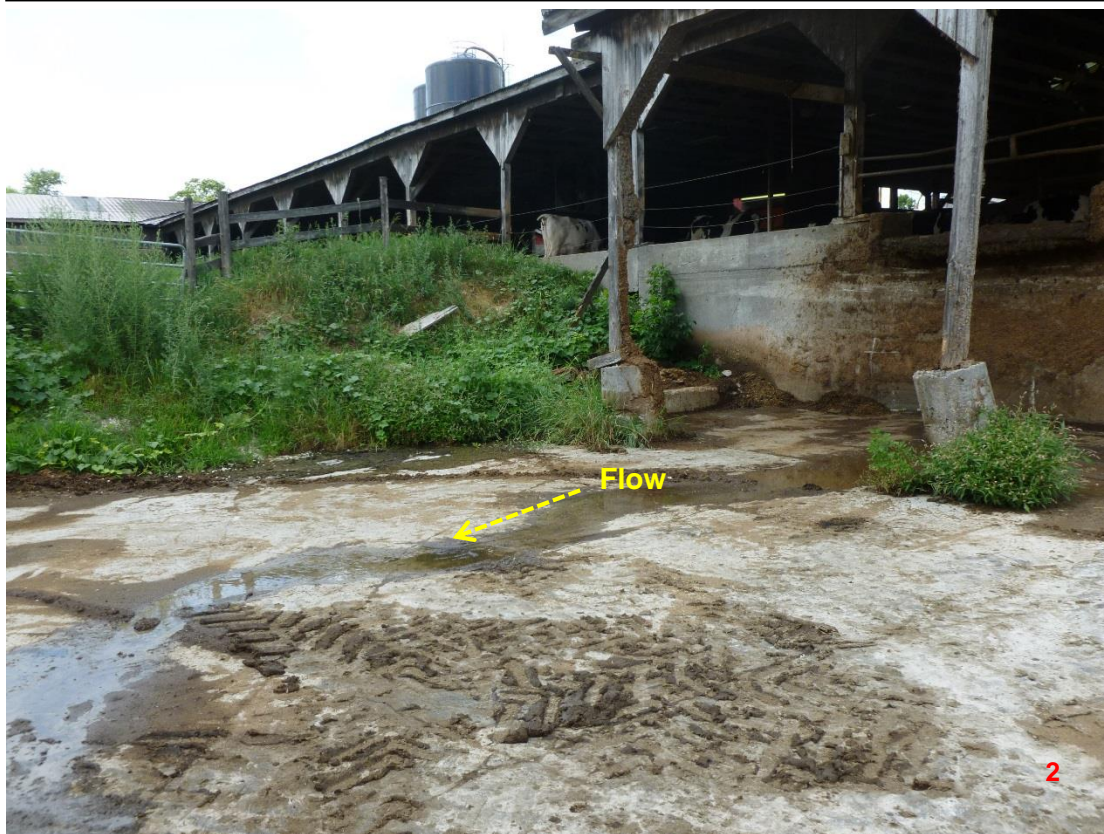
Picture 2 – Foster Brothers Farm, 58 Lower Foote Rd., Middlebury, VT – 07/29/14  
Manure transfer area on the east side of the barns (flow toward the drain).

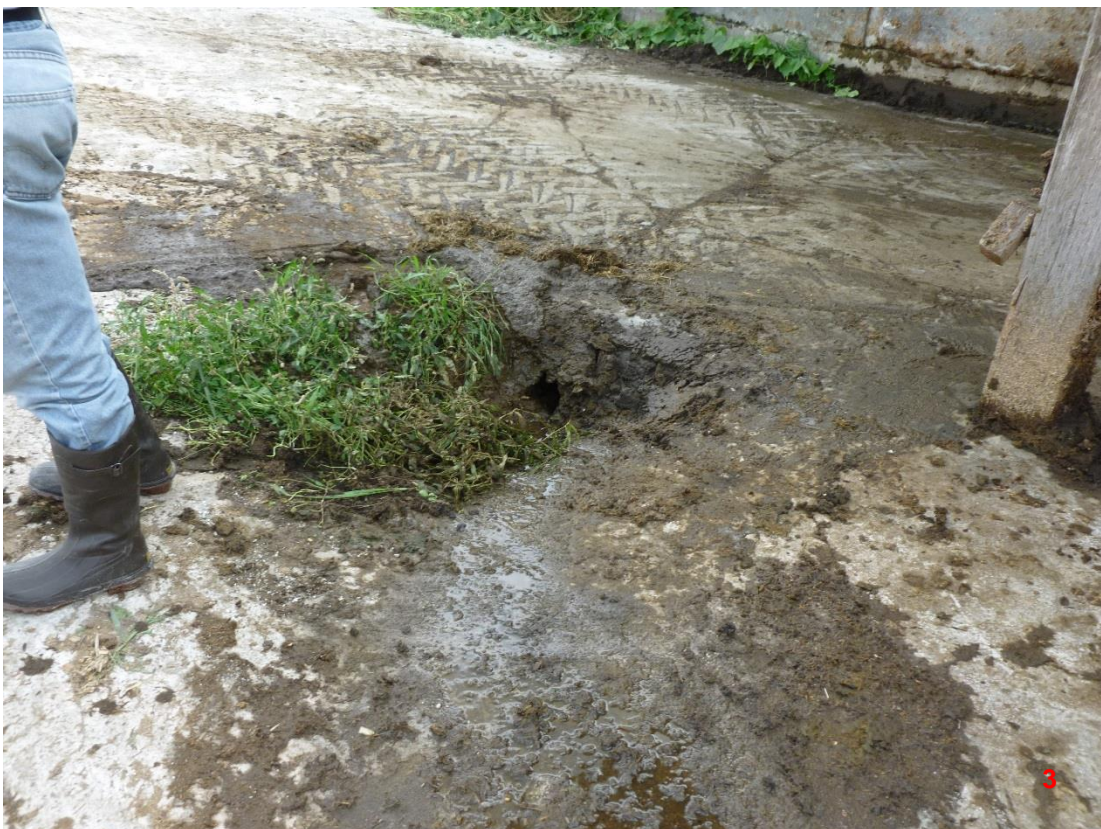
Picture 3 – Foster Brothers Farm, 58 Lower Foote Rd., Middlebury, VT – 07/29/14  
Drain on the concrete pad, partially covered in solids, on the east side manure transfer area.

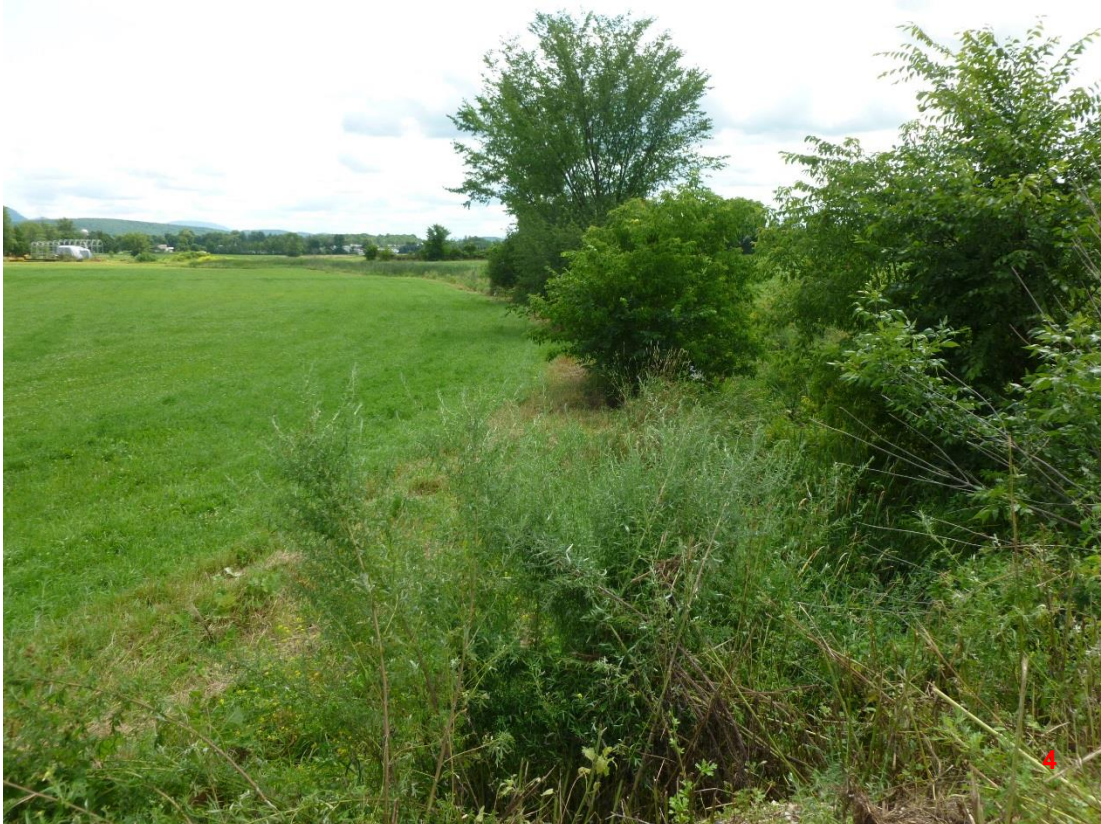
Picture 4 – Foster Brothers Farm, 58 Lower Foote Rd., Middlebury, VT – 07/29/14  
Vegetated drainage ditch (looking south) that receives runoff from the manure transfer areas.

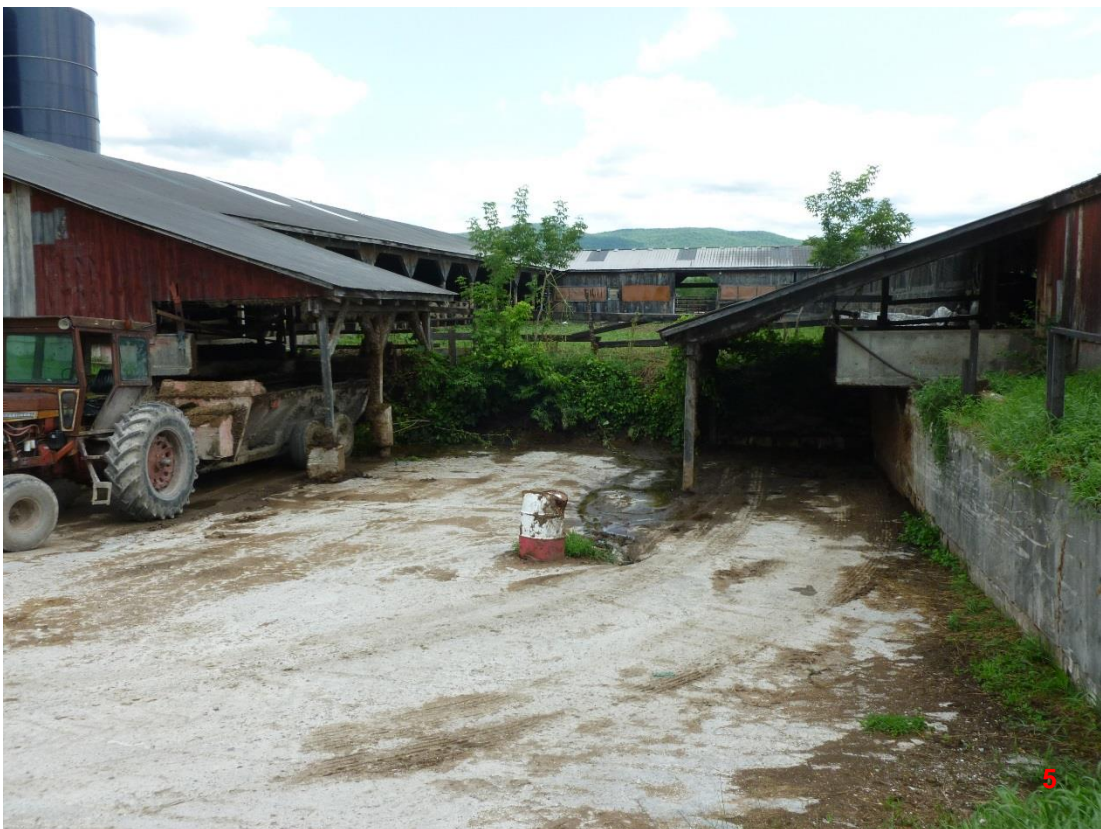
Picture 5 – Foster Brothers Farm, 58 Lower Foote Rd., Middlebury, VT – 07/29/14  
Manure transfer area on the west side of the barns.

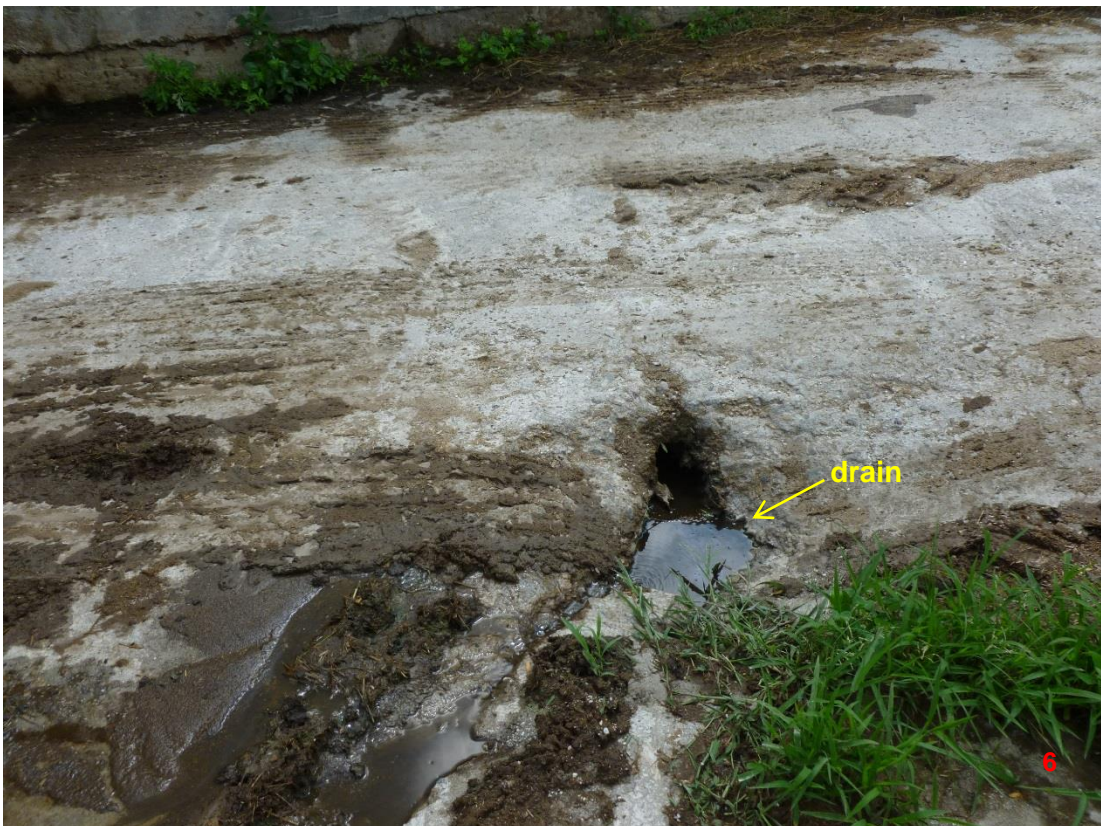
Picture 6 – Foster Brothers Farm, 58 Lower Foote Rd., Middlebury, VT – 07/29/14  
Drain on the concrete pad in the west side manure transfer area.

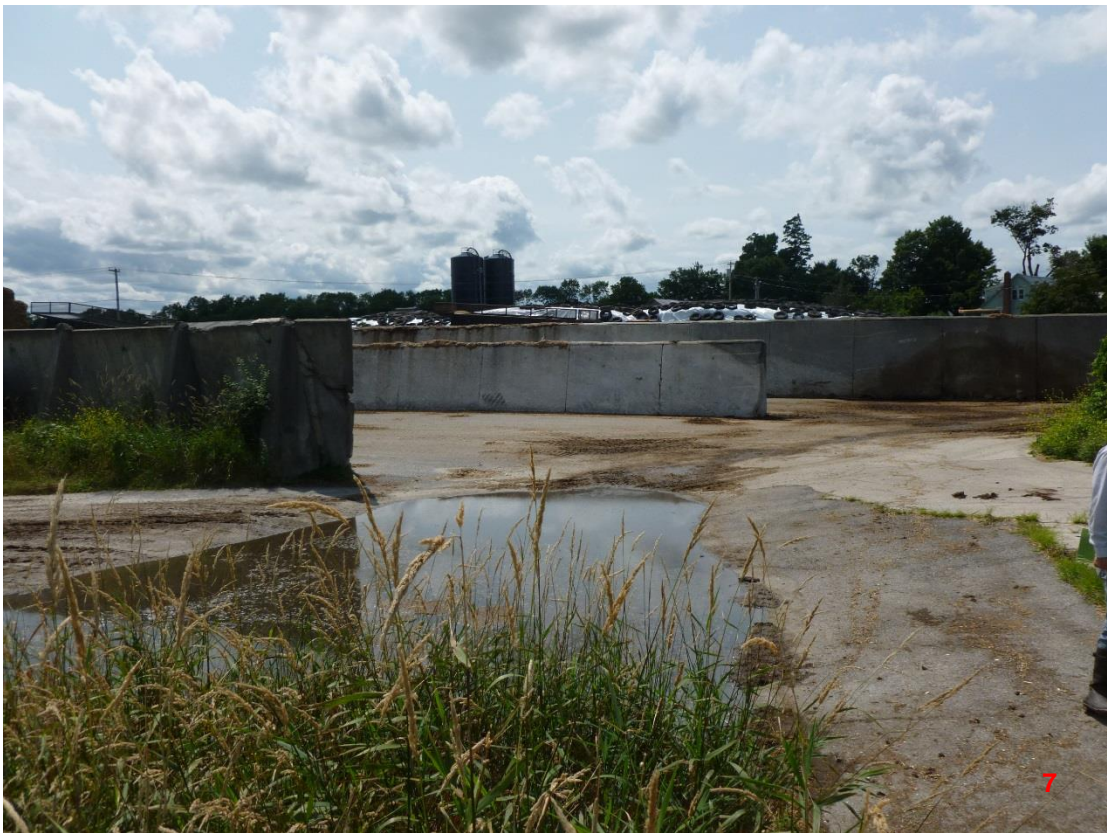
Picture 7 – Foster Brothers Farm, 58 Lower Foote Rd., Middlebury, VT – 07/29/14  
View of silage bunkers, graded toward the silage leachate/runoff collection system.

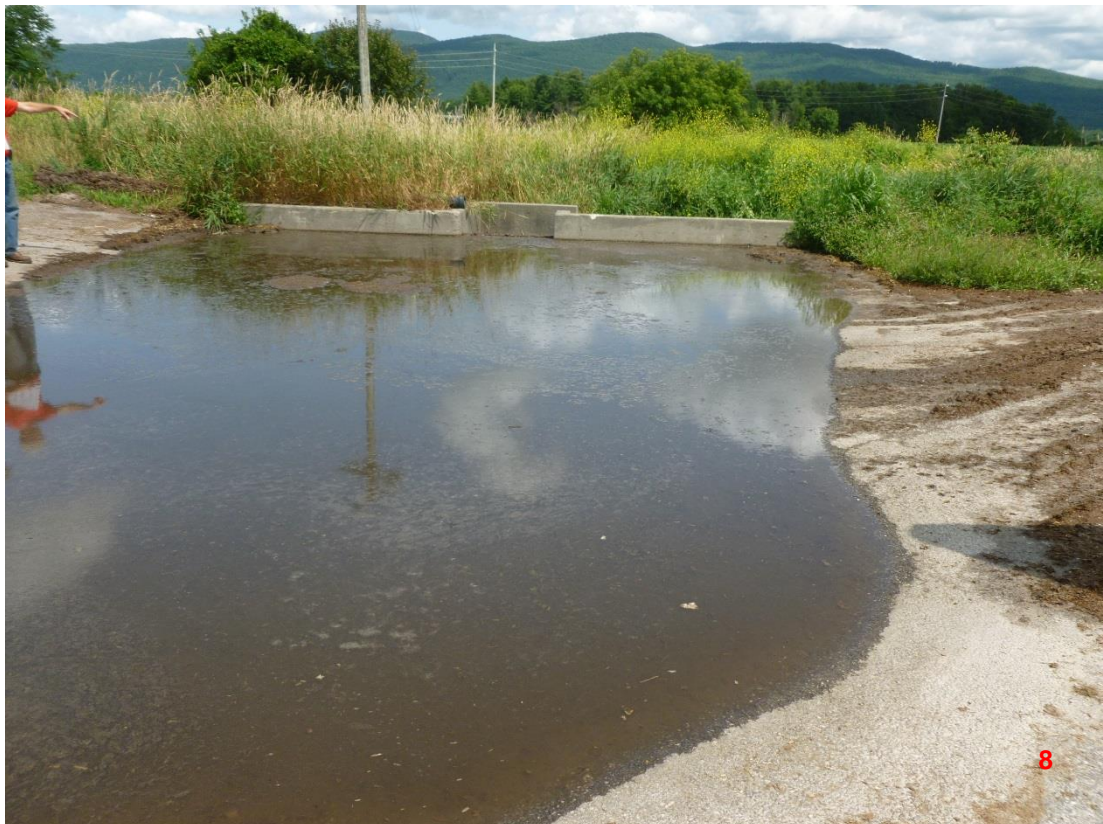
Picture 8 – Foster Brothers Farm, 58 Lower Foote Rd., Middlebury, VT – 07/29/14  
Silage leachate/runoff collection system, with water pooling around the concrete drain bay.

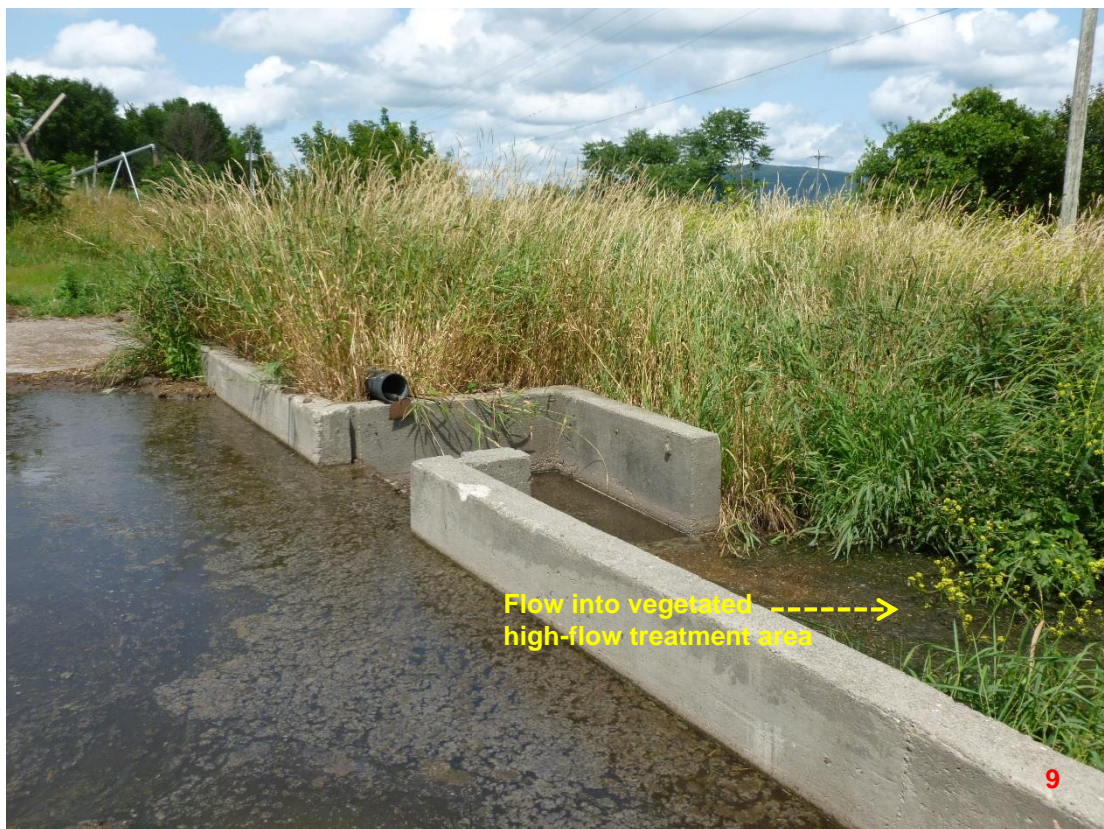
Picture 9 – Foster Brothers Farm, 58 Lower Foote Rd., Middlebury, VT – 07/29/14  
Solids build-up at the concrete drain bay for the silage runoff collection system.

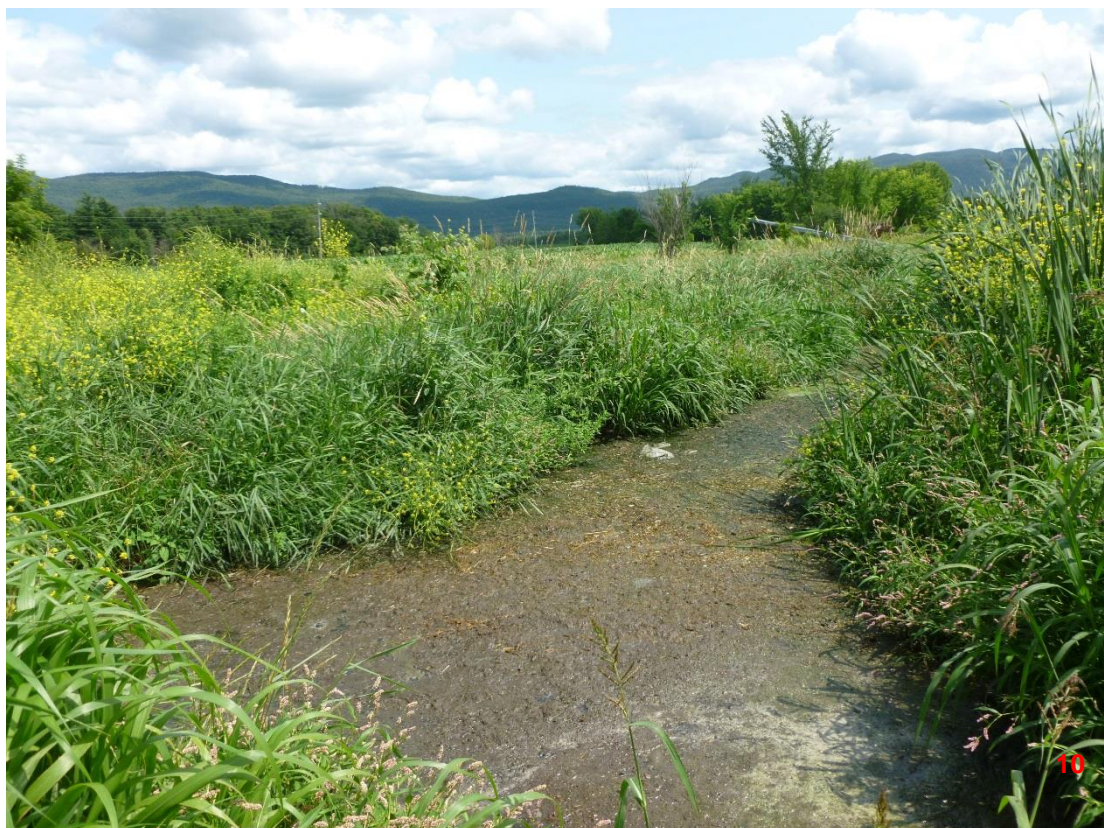
Picture 10 – Foster Brothers Farm, 58 Lower Foote Rd., Middlebury, VT – 07/29/14  
Solids accumulated and channeling in the high-flow treatment area.

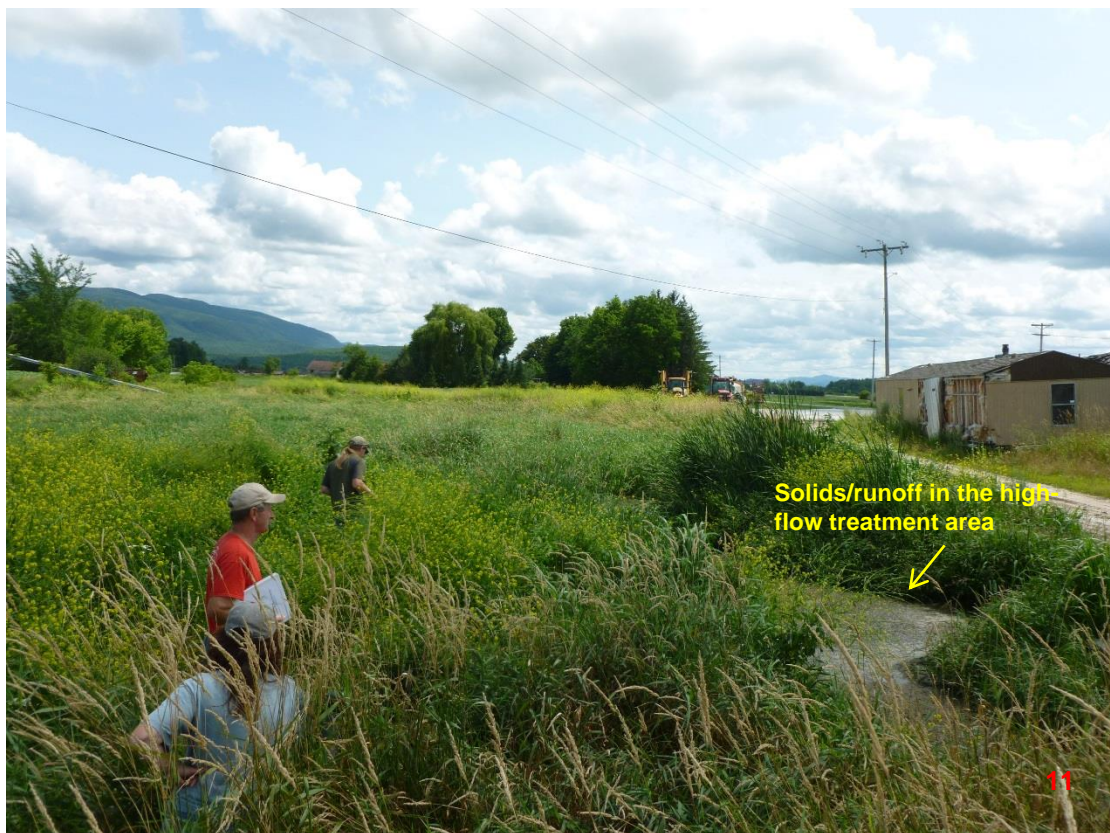
Picture 11 – Foster Brothers Farm, 58 Lower Foote Rd., Middlebury, VT – 07/29/14  
Solids accumulated in the silage collection system's high-flow treatment area.

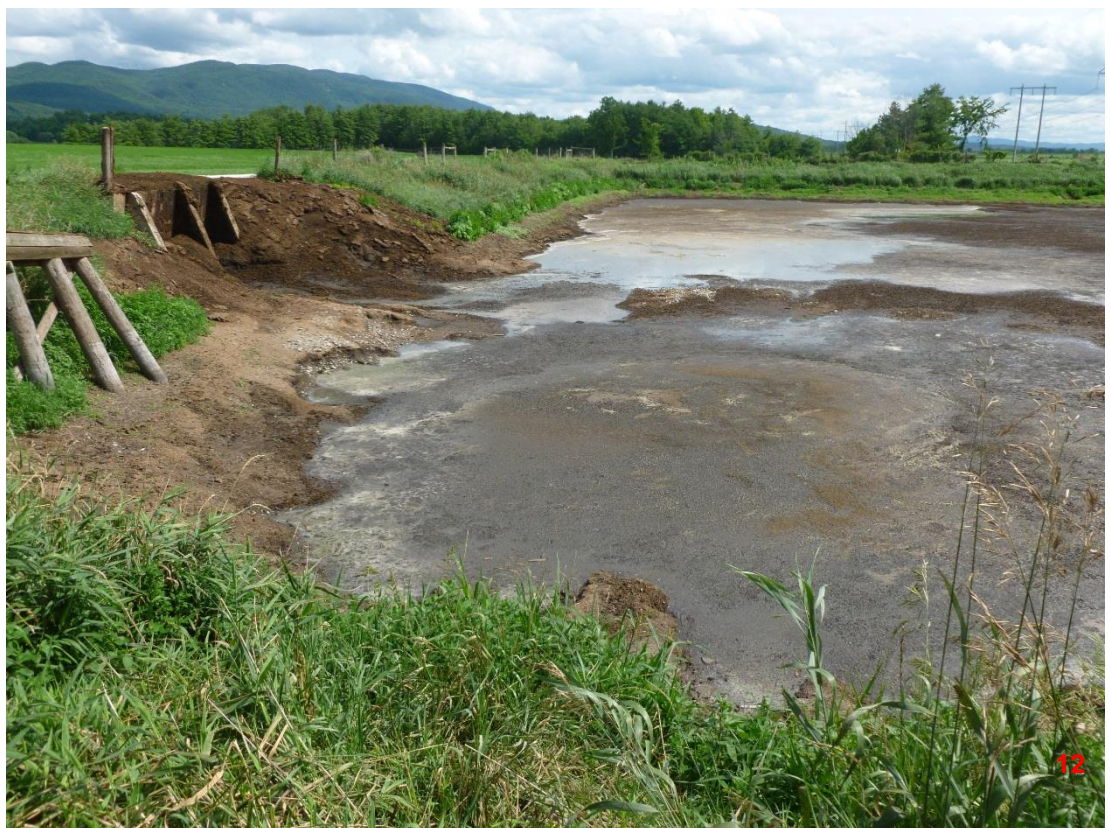
Picture 12 – Foster Brothers Farm, 58 Lower Foote Rd., Middlebury, VT – 07/29/14  
Remote manure pit, located east of the main farm.
